**LEVEL** 12  
B.S.  
**THE PERFORMANCE OF  
SELECTED MARINE  
COATINGS  
EXPOSED TO HIGH  
VELOCITY SEAWATER**

By G. A. GEHRING, JR.  
Prepared for OFFICE of NAVAL RESEARCH

March 1979

OCEAN CITY RESEARCH CORP.

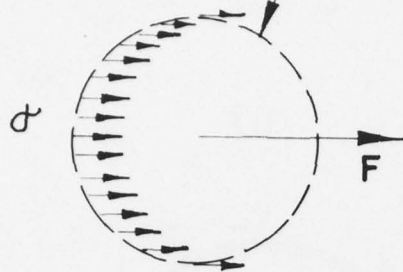
FIGURE 32 - POSSIBLE DISTRIBUTION OF TENSILE STRESS AROUND  
BLISTER.

If it is assumed that the resultant hydrodynamic load creates a tensile stress in the coating distributed about the perimeter of the blister somewhat like shown in Figure 32, then a rough approximation of the coating area over which the applied load is distributed is  $\frac{1}{2} \times \text{circumference of blister} \times \text{coating thickness}$ . Using the dimensions of the blister assumed above, the cross-sectional area is calculated as follows:

LIMIT OF COATING DISBONDMENT  
BENEATH BLISTER.
